**Department of the Navy  
Base Realignment and Closure Program  
Management Office West**

**Remedial Action Completion Report,  
Durable Cover, Groundwater  
Treatment, and Institutional Controls  
for Parcel G, Hunters Point Naval  
Shipyard, San Francisco, California**

March 2014

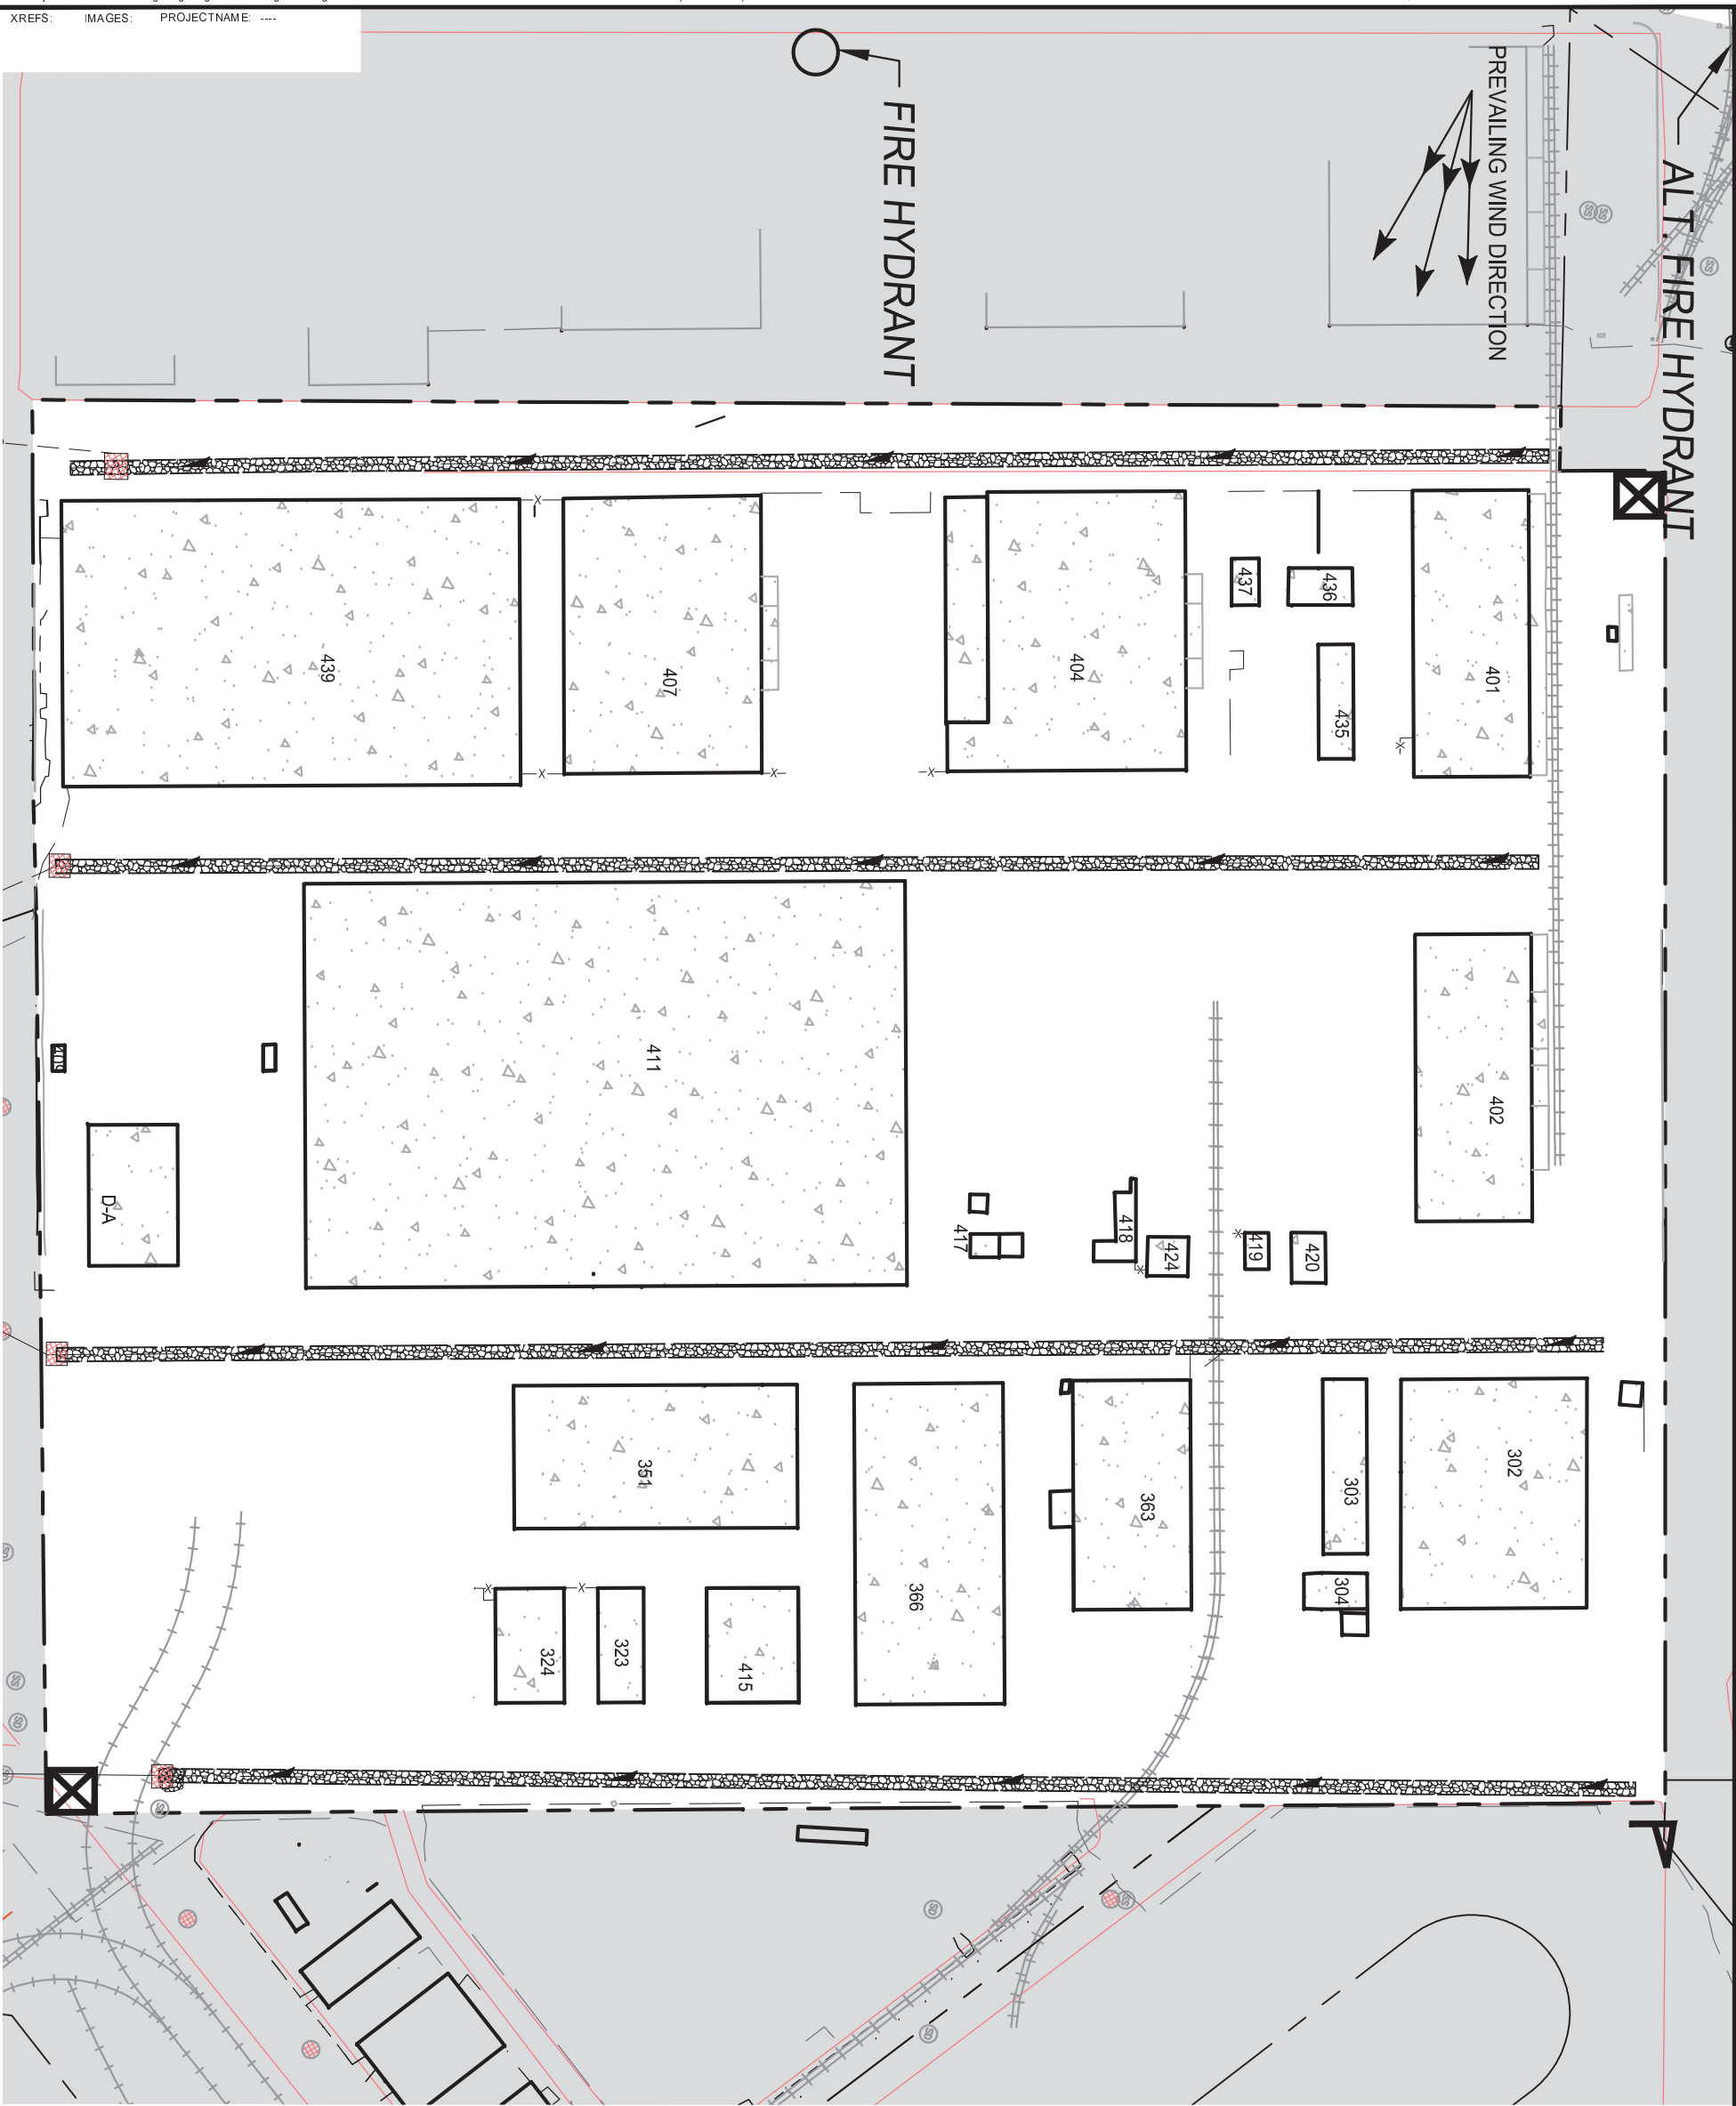
NAVAL BASE REALIGNMENT AND CLOSURE PROGRAM  
SAN FRANCISCO, CALIFORNIA  
PARCEL G, HUNTERS POINT NAVAL SHIPYARD  
DUST CONTROL PLAN

UPWIND AND DOWNWIND AIR SAMPLING STATIONS  
MAY BE RELOCATED BASED ON CHANGES IN THE  
DIRECTION OF PREVAILING WINDS ON PARCEL G AS  
INDICATED BY THE ON SITE WINDSOCK.

WIND DIRECTION: PER SOUTHWEST NAVAL FACILITIES  
ENGINEERING COMMAND WIND ROSE PLOTS OF  
HUNTERS POINT SHIPYARD 08/06/00-10/12/00
